Manhole Inspection Summary

Manhole # S11S__013MH

Insp Date: **4/4/08 9:21 AM**

Location Address: **809 S. Caton Ave**

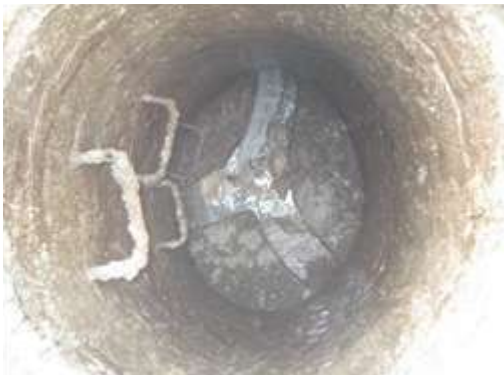
Defect 1

bench debris, corroded steps/ chimney and corbel infiltration evidence

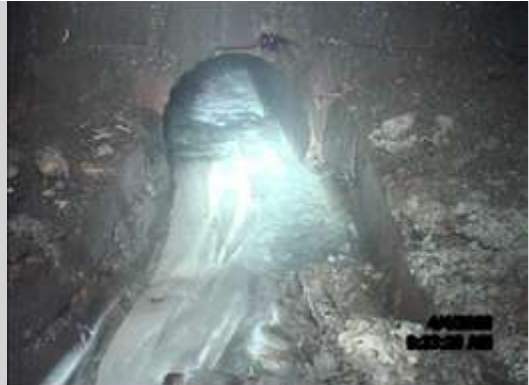
12 O'Clock Outflow

Pipe Height: **8.4** (in.) Rod and Bar (Angled)
Pipe Material: **Clay** ☐ Pipe Lined
Invert Depth: **8.67** (ft.) Flow Characteristics: **Slow**
Deposits: ☐ None ☐ Mud ☒ Sludge ☒ Debris ☐ Grease
Silt Depth: **4** (in.) Deposits Extent: **Medium**
Infiltration: **Evidence** Pipe Seal Cond: **Unknown**

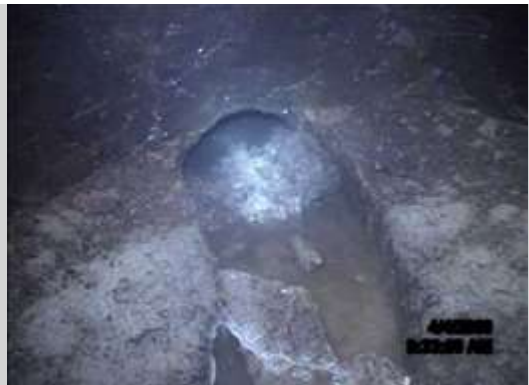
4 O'Clock Inflow

Pipe Height: **0** (in.) Direct
Pipe Material: **Clay** ☐ Pipe Lined
Invert Depth: **7.40** (ft.) Flow Characteristics: **Slow**
Deposits: ☒ None ☐ Mud ☐ Sludge ☐ Debris ☐ Grease
Silt Depth: **0** (in.) Deposits Extent:
Infiltration: **Evidence** Pipe Seal Cond: **Unknown**

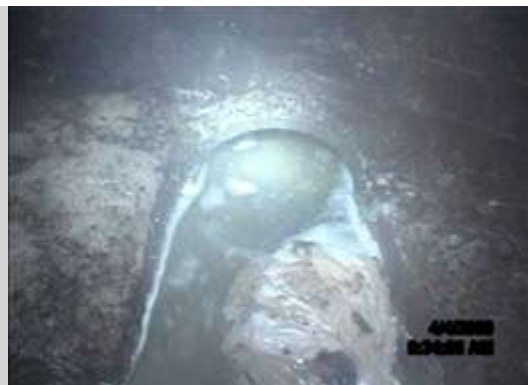
8 O'Clock Inflow

Debris in channel

Infiltration: **Evidence** Pipe Seal Cond: **Unknown**
